LAKE LANSING DAM INSPECTION REPORT

Dam Identification No. 1957
Meridian Township, Ingham County, Michigan

12/2/2016

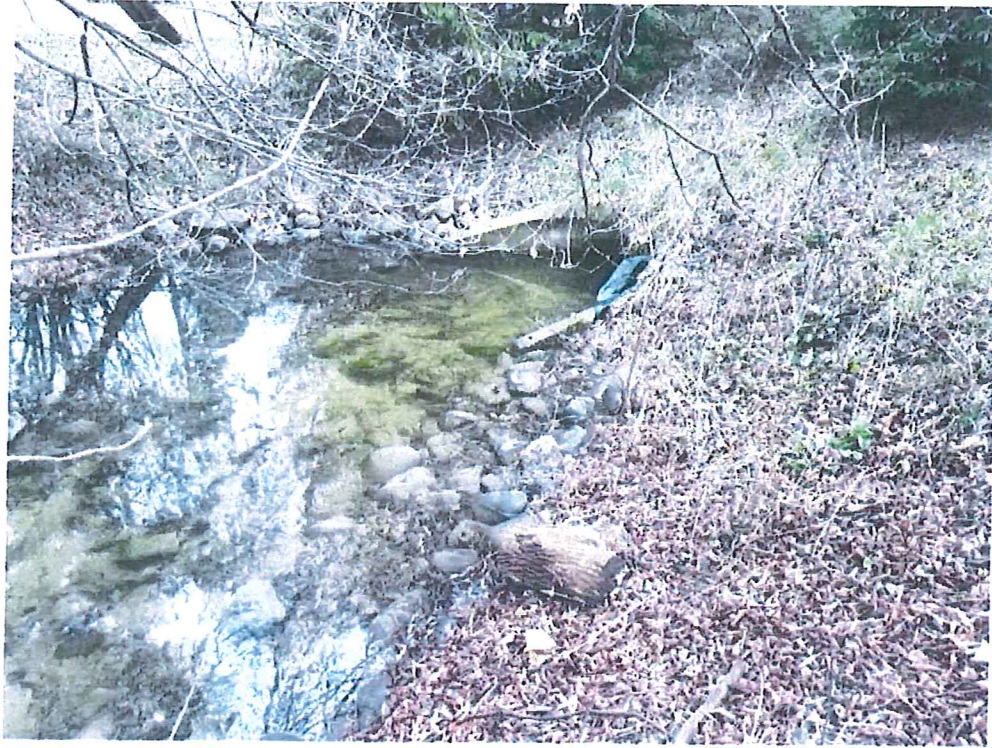
Figure 1 – Marsh Rd. Outlet Structure

Figure 1: Shows outlet structure under Marsh Road.

The outlet culvert under Marsh Road was recently upgraded in 2009 – 2010 by the Ingham County Road Commission and seems to be in very good condition at this time.

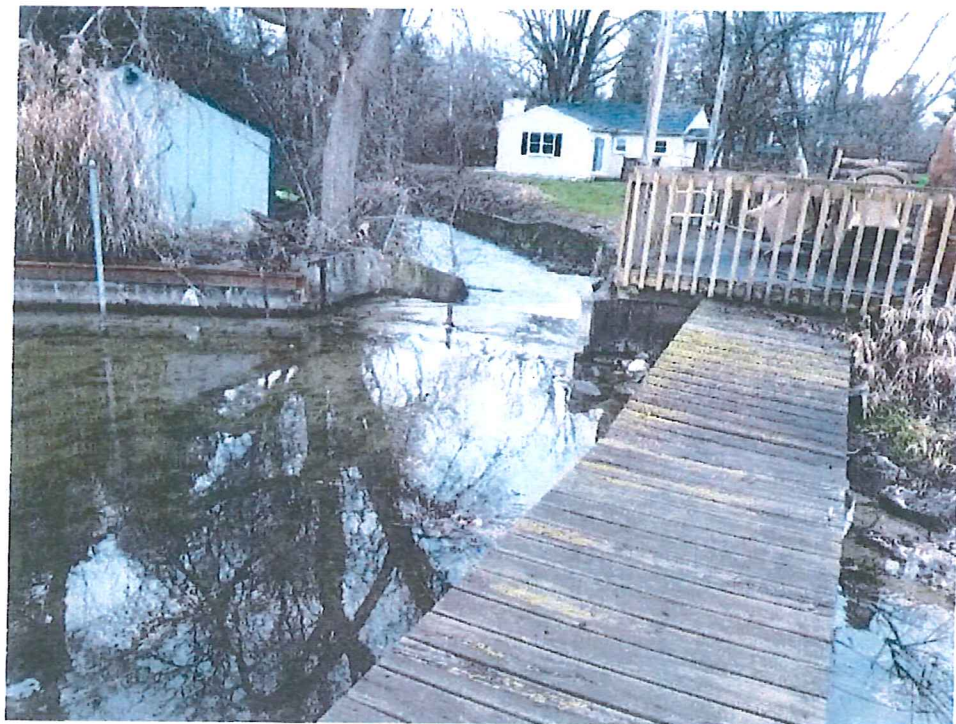
Figure 2 – Approach to Spillway from Dock

Figure 2: Shows the approach to the spillway observed from the landowners dock.

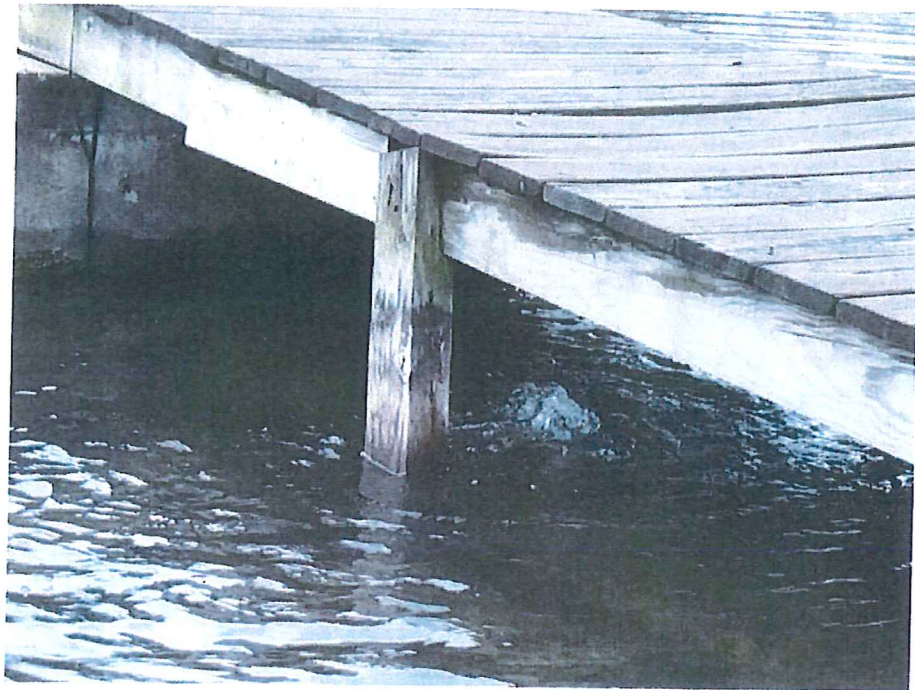
Figure 3 – Intake Pipe Damage

CMP pipe is in poor condition. Evidence of holes in the pipe. Pipe end seems to be surrounded with sediments which some of it made it downstream when the valve was opened up, end treatment is recommended.

Figure 3: Indicates where the holes in the intake pipe sidewalls are currently present.

The intake pipe which is located immediately underneath the wooden dock has rusted out and is pitted in many locations along its length. The condition could be observed readily when the valve is operational as bubbles are seen where holes are present. Furthermore, the intake pipe lacks any screens as to prevent fish or debris from washing into the drain. End treatment is recommended to prevent debris from sealing the pipe end completely.

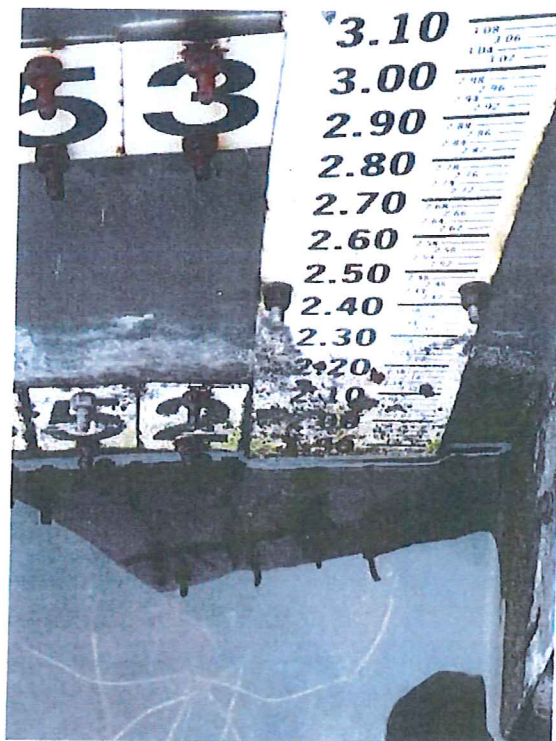
Figure 4 – Water Level

Figure 4: Indicates the current water level in the lake at the time of the survey as indicated in the report.

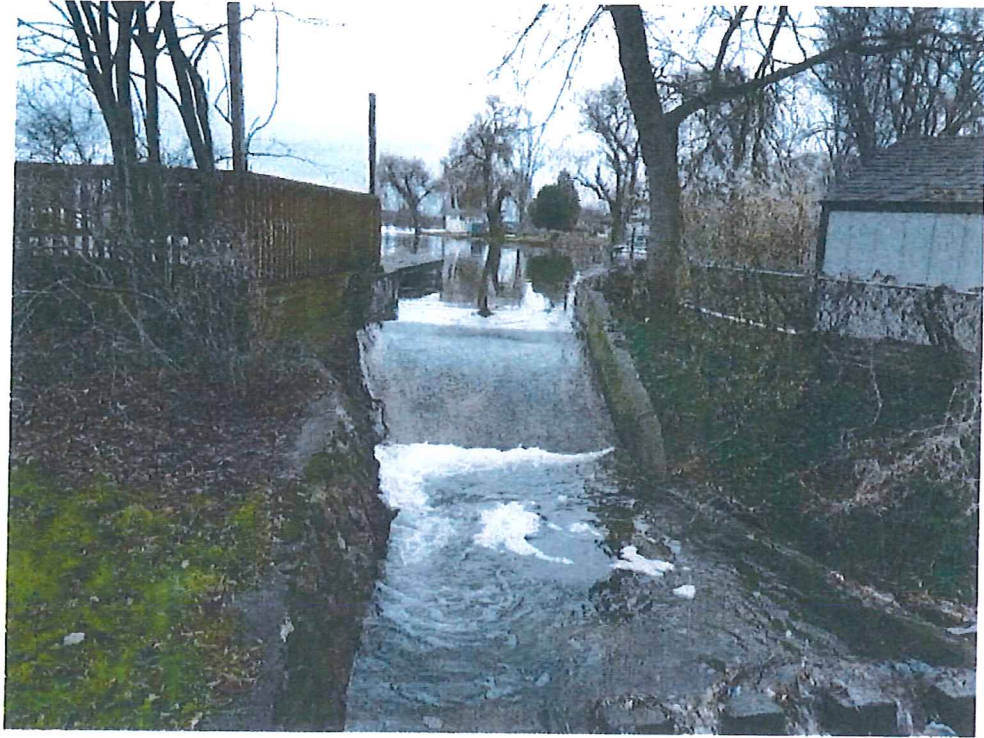
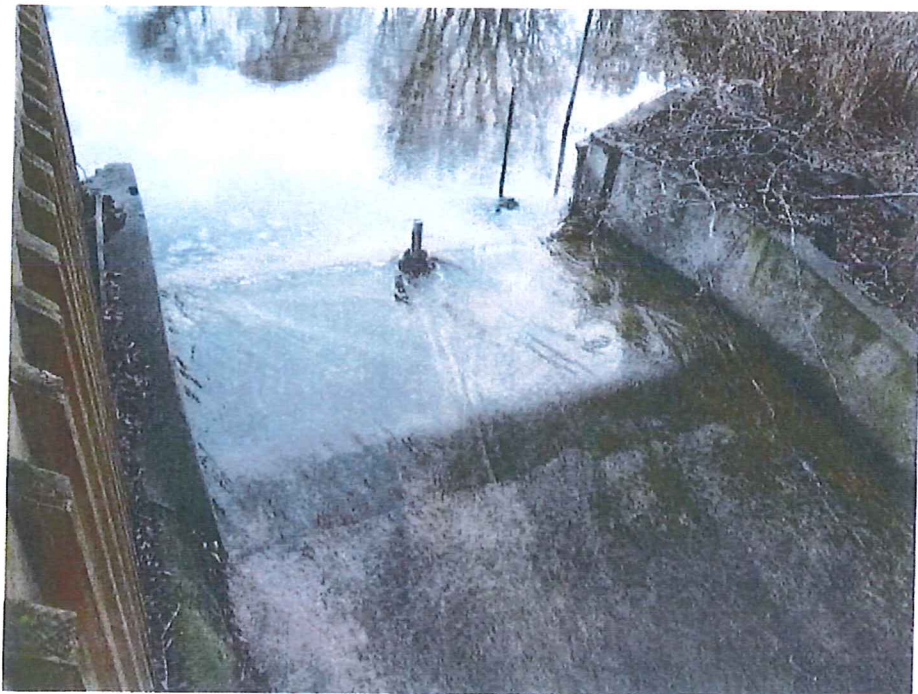
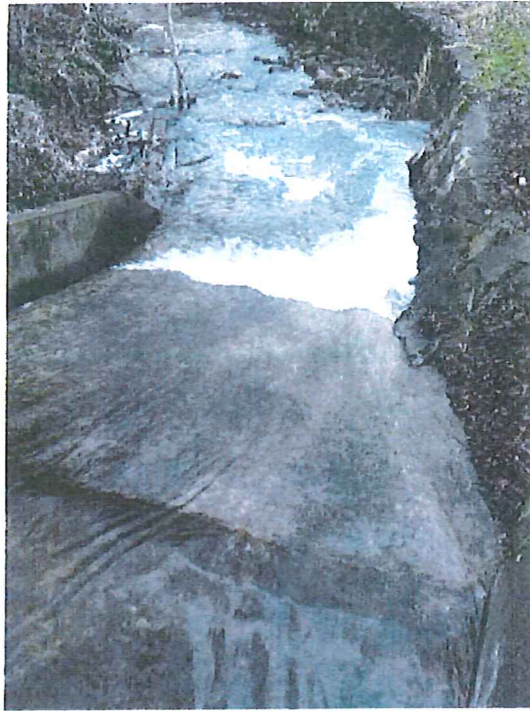
Figure 5, 6, and 7: Shows a look at the dam, weir and spillway areas.

The spillway and water level control structure are in satisfactory condition with some minor cracks and spalling. The spillway spalling concrete along the right side of the channel need to be monitored and repaired as needed. However, it may be best to consider revamping the improvements to deal with the control structure, still basin, sheet metal corrosion, overflow pipe and spillway into one project to control costs.

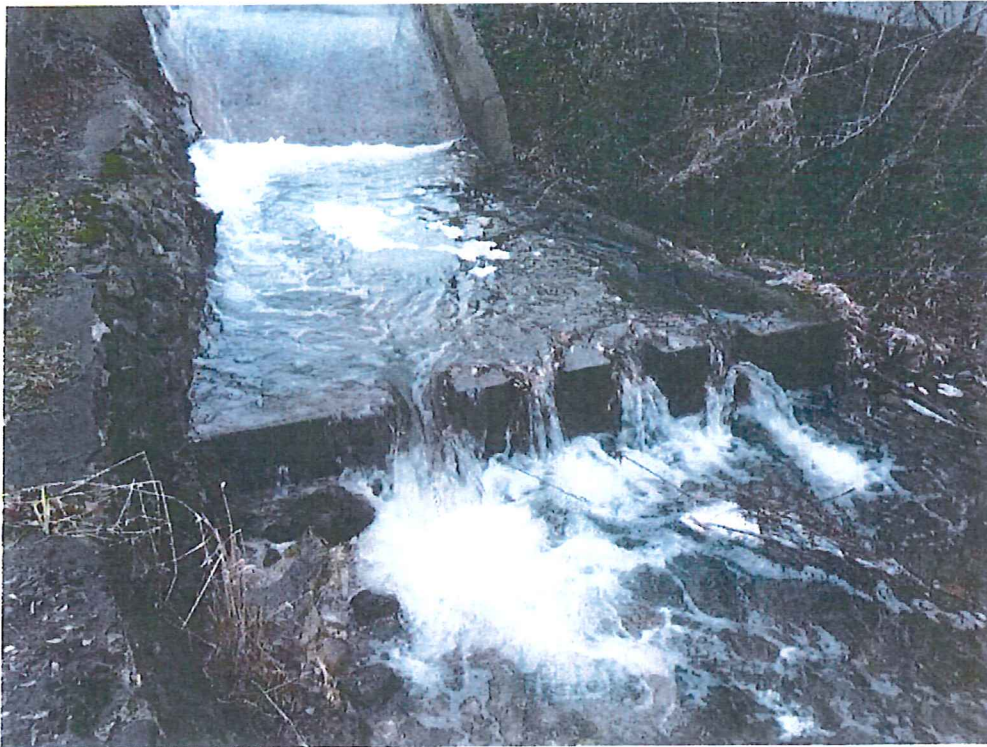
Figure 8 – Stilling Basin

Figure 8: Shows the area of the concrete stilling basin looking towards the lake.

The still basin at the bottom of the spillway is usually full throughout the year and it is a cause for foul smell from stagnant water and decomposed fish during the summer months. It is recommended that the still basin be revised to allow for natural flow with the appropriate energy dissipaters and eliminate water and fish pooling in the basin.

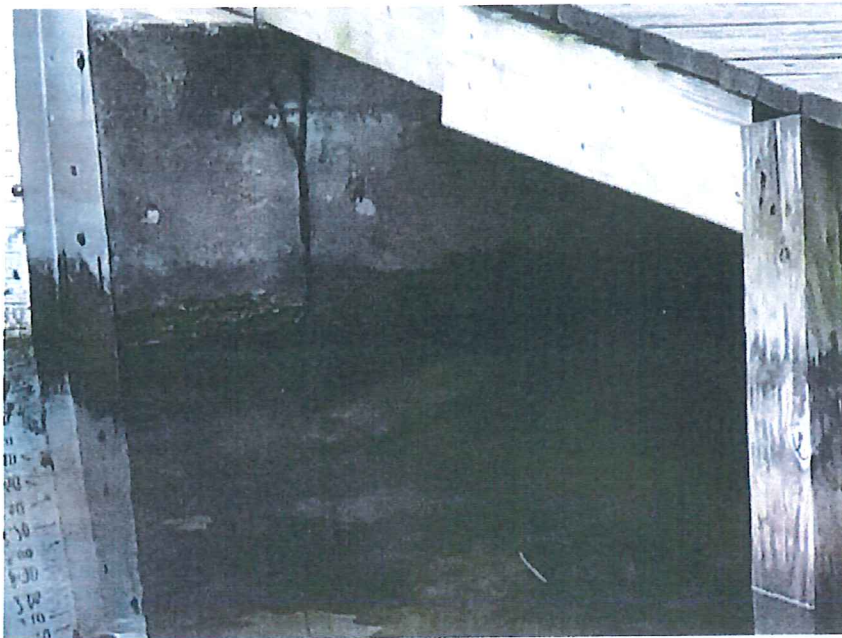
Figure 9 - Deteriorated Concrete Structure

Figure 9: Highlights the deteriorated concrete of the structure supporting the intake pipe.

The concrete spillway and manholes seem to be in fairly good shape with minor cracking that need to be addressed. However, the concrete structure supporting the inlet pipe is in deteriorated state and needs to be replaced when the fix is approved for the inlet pipe replacement/repair.

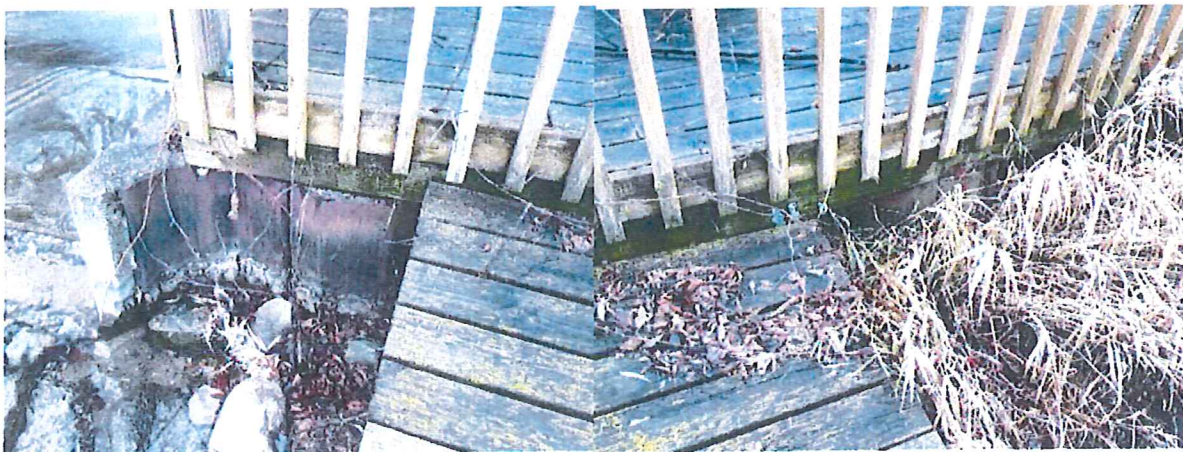
Figure 10 - Sheet Pile Right of Spillway

Figure 10: Shows the corroded steel sheet piling right of the spillway.

The sheet piling has shown significant signs of corrosion to the areas that are readily exposed and needs to be mitigated. Replacement may be an option but other means could be considered such as restoration and painting of the steel while installing an outside concrete barrier for further protection. However, earthen embankment seems to cover the majority of the sheet piling and provide some major of protection at this time.

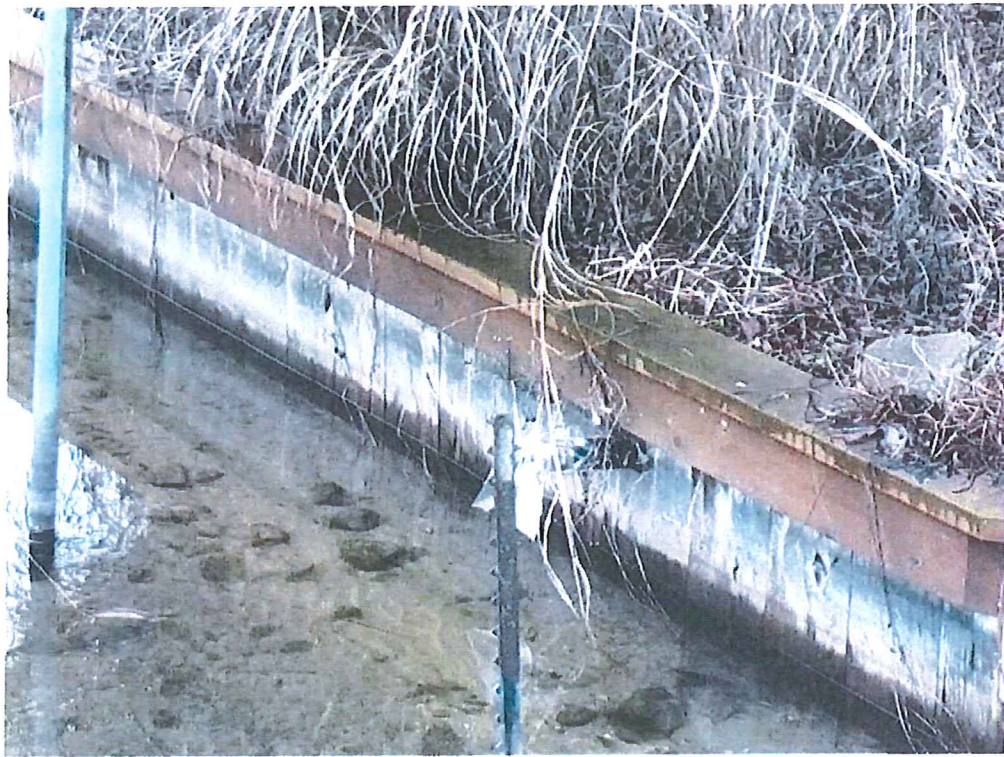
Figure 11 – Concrete Sea Wall Left of Spillway

Figure 11: Shows the concrete sea wall left of the spillway.

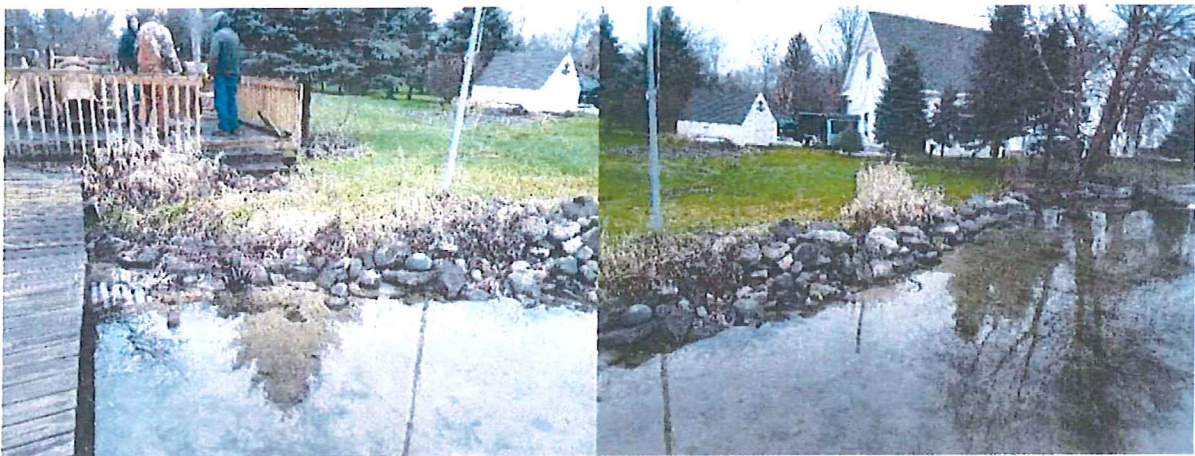
Figure 12 – Riprap Shoreline Right of Spillway

Figure 12: Shows the riprap shoreline right of the spillway.

No significant erosion was observed at the time of inspection. It is recommended regular upkeep be done to prevent future erosion.

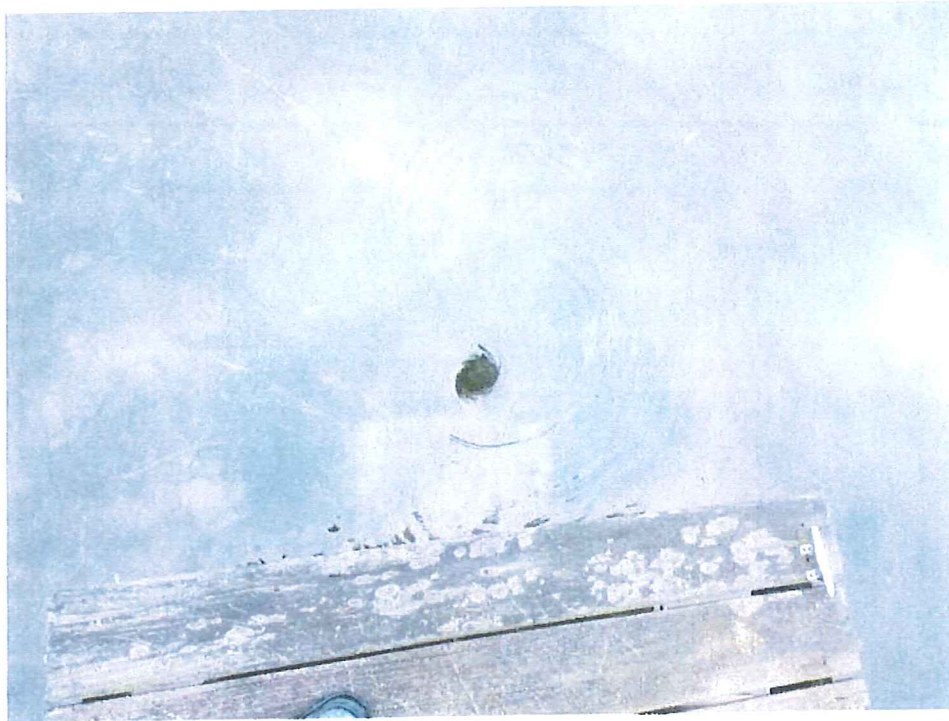
Figure 13 – Intake Pipe

Figure 13: Shows the intake pipe.

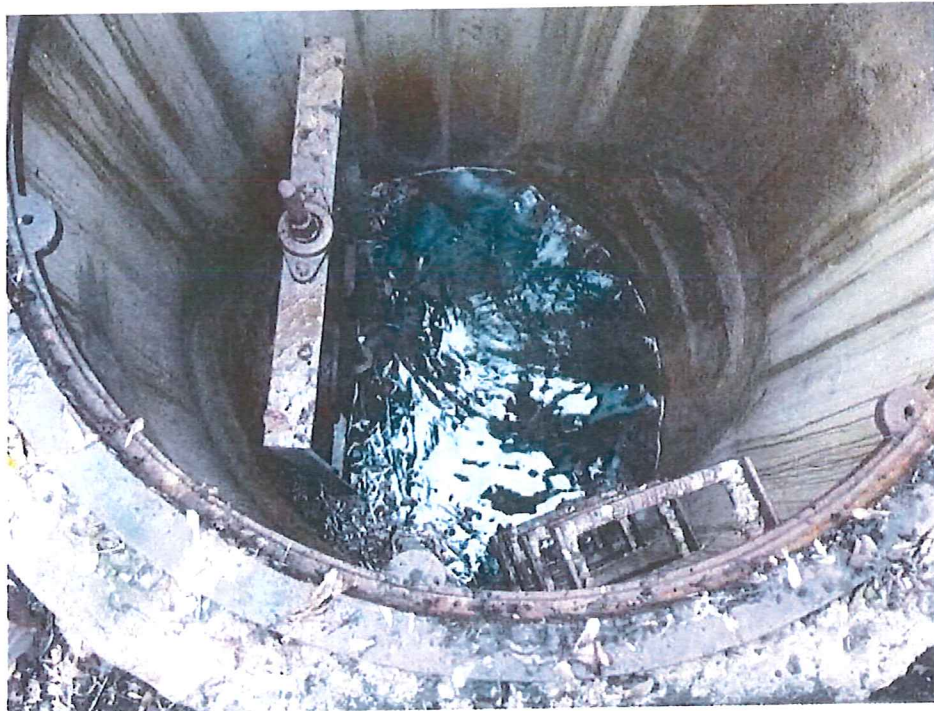
Figure 14 – Control Valve

Figure 14: Shows the slide gate within the intake structure that controls the level of the lake outside the weir/spillway control. During the inspection, the gate seems to have been sealed tight.

The slide gate operates fairly well the majority of the time but has been known to allow for water seepage when sediments are present in the system. Access to the control valve structure is somewhat problematic as it is located underneath a wooden panel in the deck constructed by the homeowner. The steel manhole cover needs to be replaced by a hatch that is easier to open than the current condition which requires at least two staff members to lift.
