# LAKE LANSING DAM INSPECTION REPORT

Dam Identification No. 1957  
Meridian Township, Ingham County, Michigan

12/29/2022

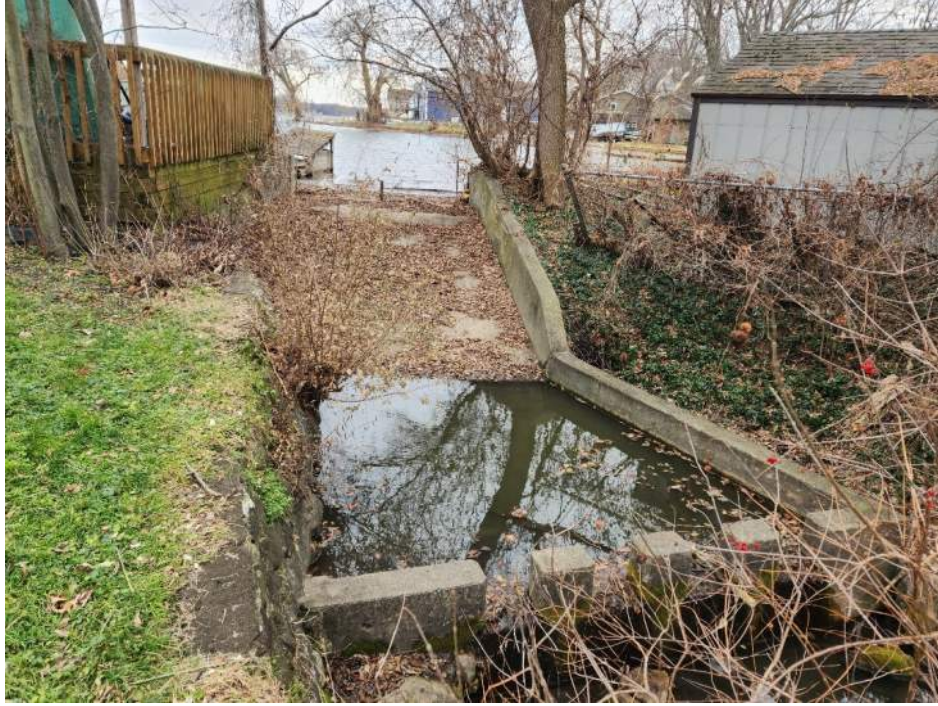
**Figure 1 – Still Basin**

Figure 1: Shows the concrete stilling basin looking towards the lake.

The still basin at the bottom of the spillway is usually full throughout the year and it is a cause for a foul smell from stagnant water and decomposed fish during the summer months.

6. Evaluate the need to replace the still basin with other means of energy dissipaters.
7. Perform regular clearing and grubbing within the open drain and around culvert.

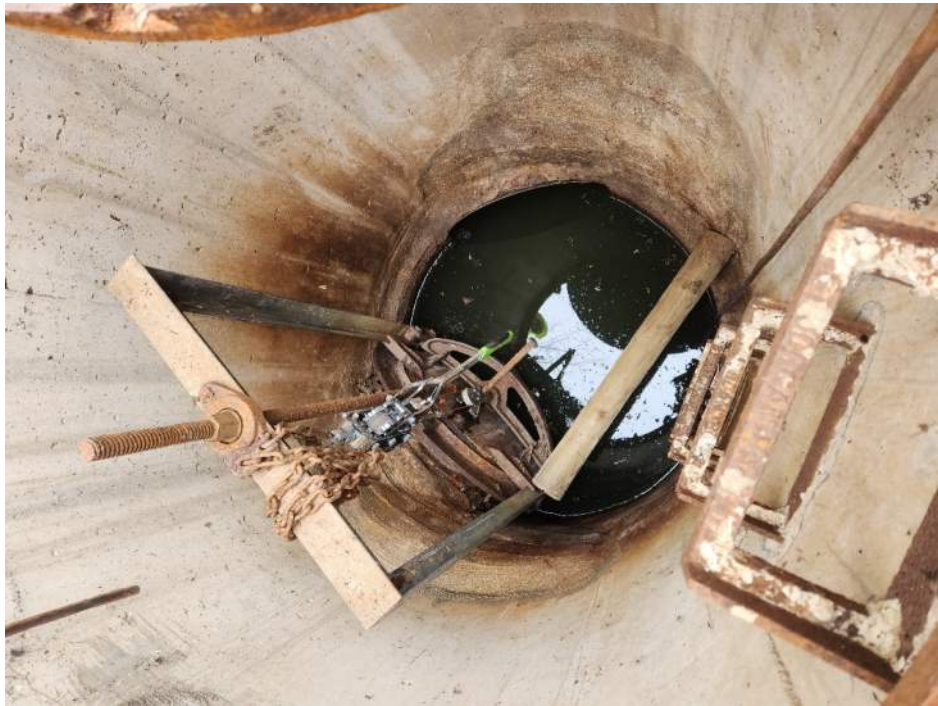
**Figure 2 – Slide Gate (Valve)**

Figure 2: Shows the slide gate within the intake structure that controls the level of the lake outside the weirs/spillway control. Some leakage can be seen from the valve.

The slide gate is not operational and is currently propped up by a chain and wedged with a 4x4 to maintain it in a closed position.

2. Replace or perform lining to the existing intake piping while replacing the valve control structure for lowering the lake level; Establish new uplift control for new/rehabilitated pipe with appropriate screening to prevent fish and other debris from washing downstream when the valve is open.

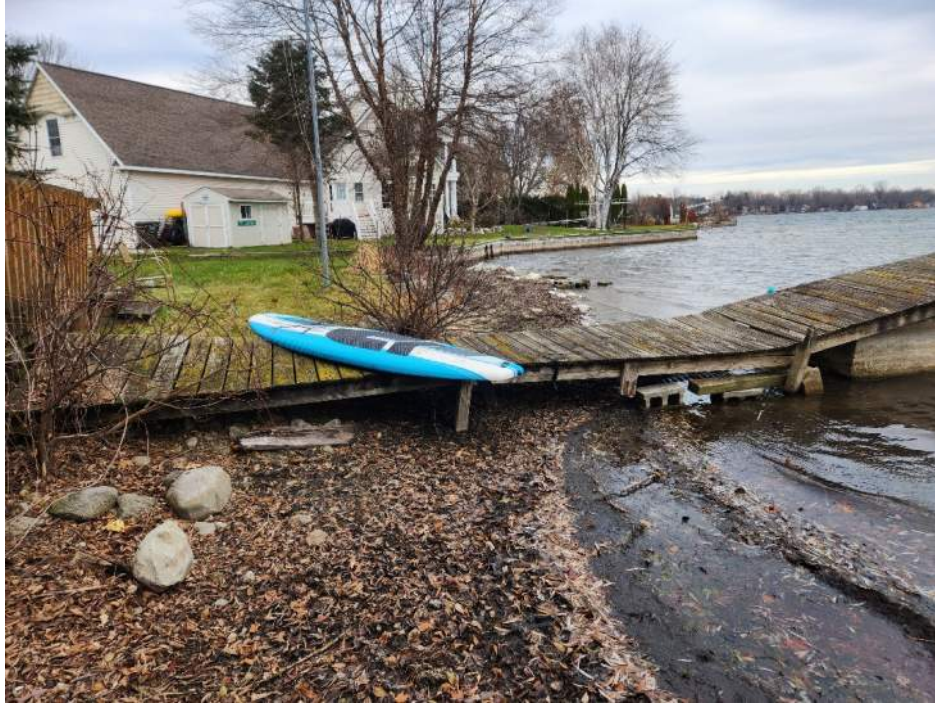
**Figure 3 – Wooden Dock**

Figure 3: Show the condition of the wooden dock.

The wooden dock is in very poor condition. The dock is unstable and unsafe to walk on. It needs to be repaired or replaced.

3. Repair damaged concrete structures.
4. Relevel water level measuring device on the concrete structure for a more accurate lake level reading.
5. Replace the wooden dock and maybe eliminate the deck over the valve control structure when performing the upgrade.

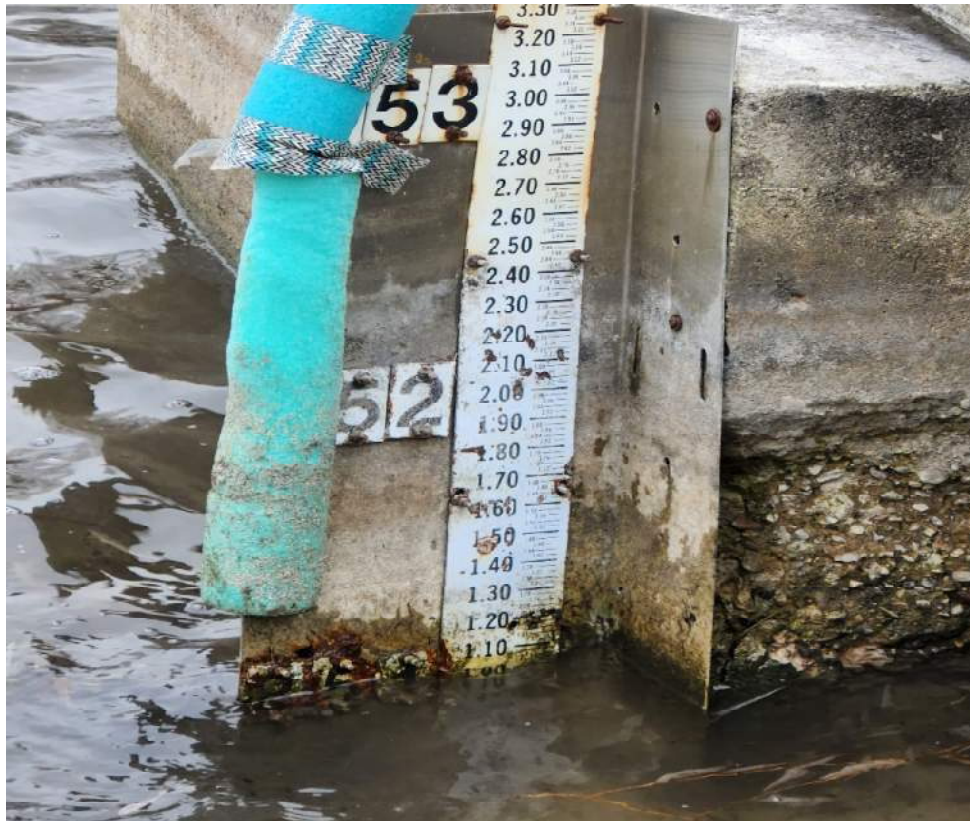
**Figure 4 – Water Level**

Figure 4: Indicates the water level of the lake at the time of inspection.

The water level measuring device located along the concrete slab at the end of the dock has shifted and needs to be relevelled to its original location. This will allow for a more accurate reading of the lake level as the water level is currently monitored on a monthly basis by maintenance staff. The installation of a remote sensor that reports water level information accessible via internet could also be installed to reduce the number of visits needed for water level monitoring.

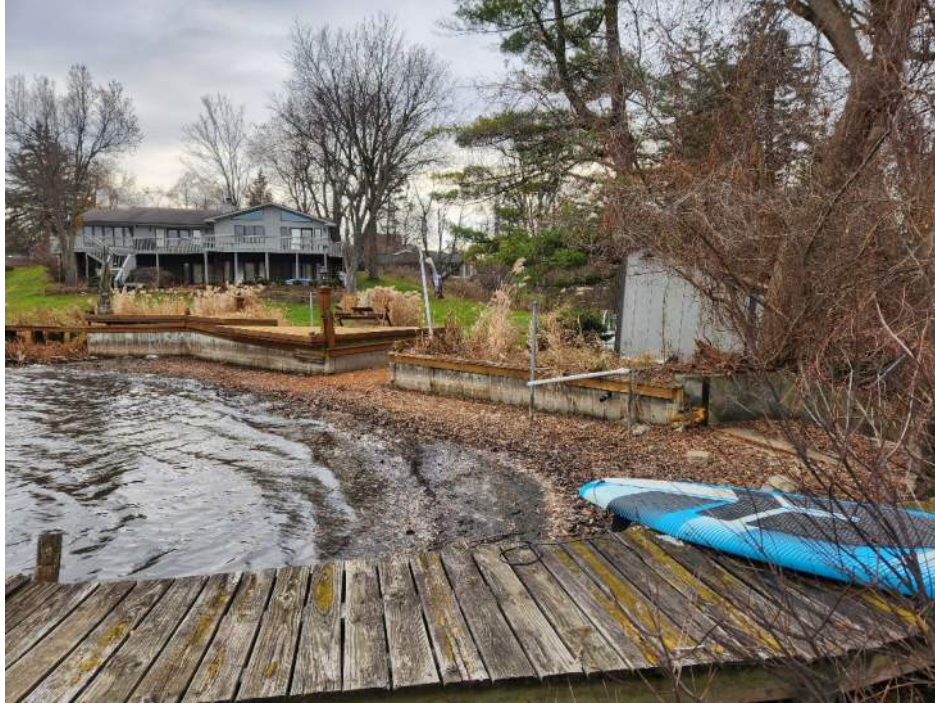
**Figure 5 – Sea Wall and Approach to Spillway from the Dock location**

Figure 5: Shows the Sea Wall and Approach to Spillway from the Dock location.

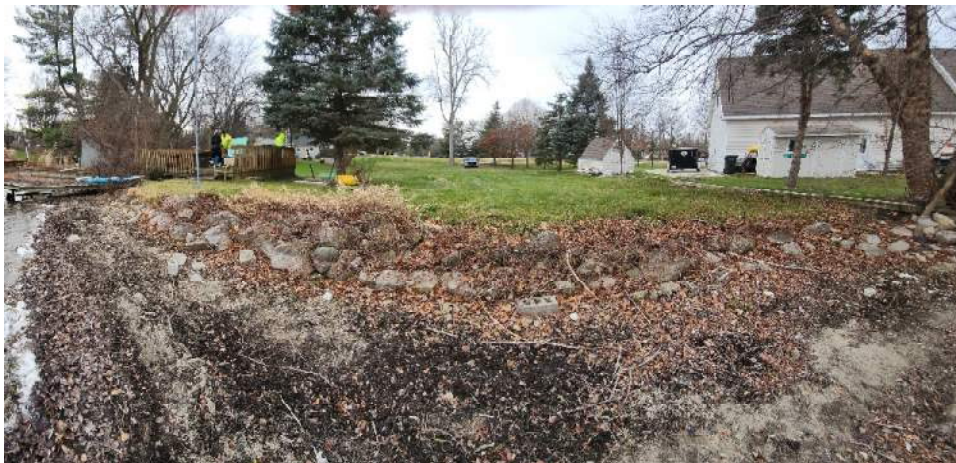
**Figure 6 – Riprap Shoreline Right of Spillway from the Dock location**

Figure 6: Shows the riprap shoreline right of the spillway.

No significant erosion was observed at the time of inspection. It is recommended regular upkeep be done to prevent possible erosion.

8. Perform regular upkeep on areas that experience erosion.

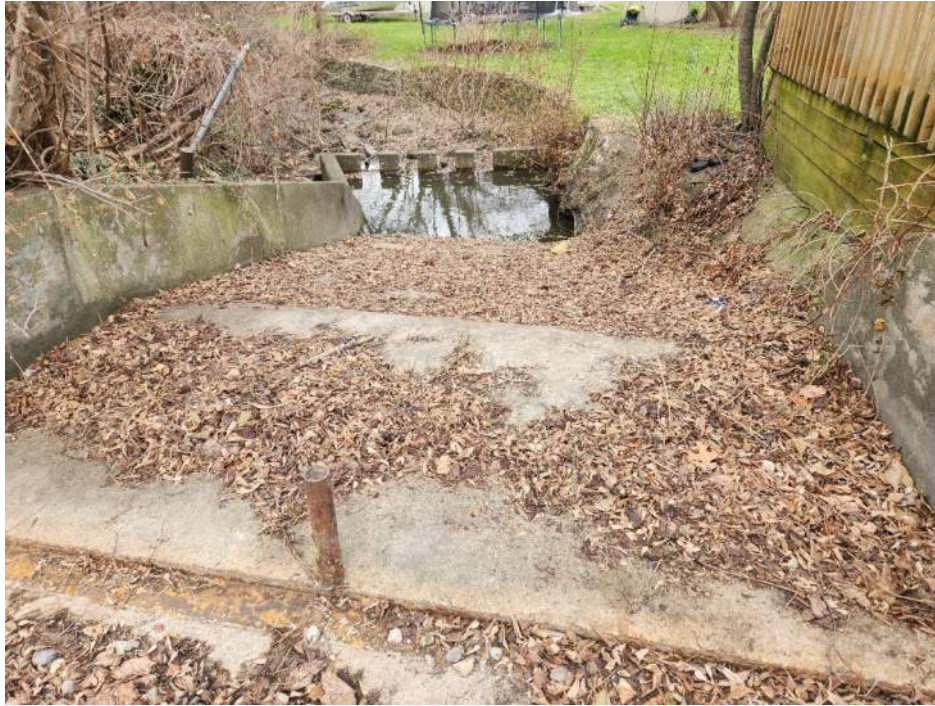
**Figure 7 – Spillway**

Figure 7: Shows the spillway.

The spillway and water level control structure are in satisfactory condition with some minor cracks and spalling. Vines seem to be growing through some of the cracks along the spillway edge. The spillway, however, does not allow for fish to pass from Lake Lansing into the Pine Lake Outlet Drain. Modifications could be made to the spillway to allow for fish passage.

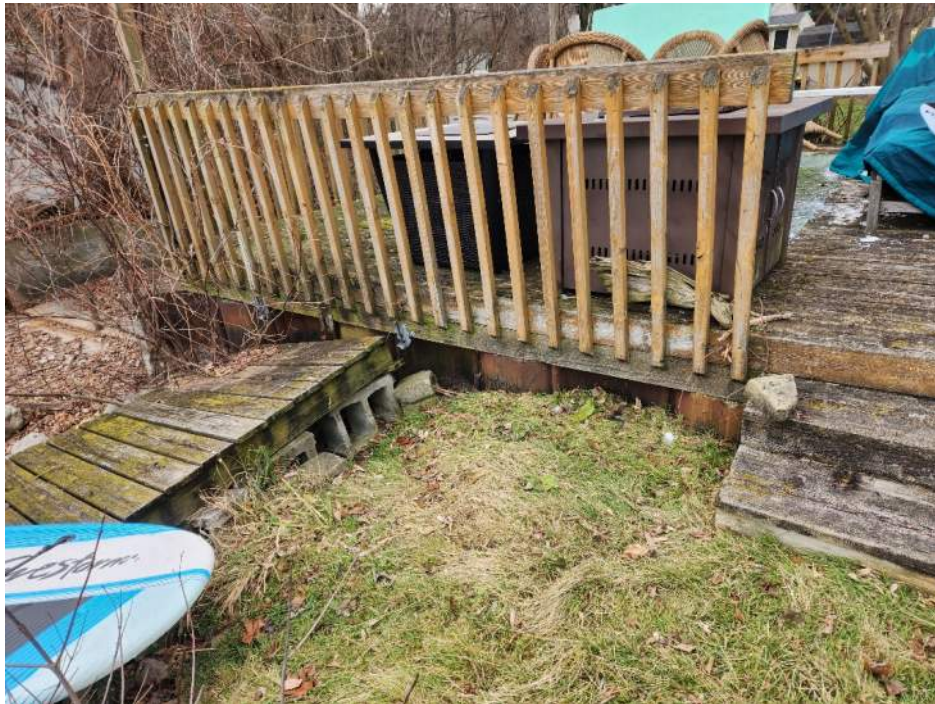
**Figure 8 – Sheet Piling Right of Spillway**

Figure 8: Shows the sheet piling under the wooden deck.

The sheet piling has shown some signs of corrosion and needs to be mitigated. Replacement may be an option, but other means could be considered such as restoration and painting of the steel while installing an outside concrete barrier for further protection.

1. Perform rehabilitation of the corroded upper portion of the sheet piling along the span of the dam. (sandblasting, painting and encasement with concrete)

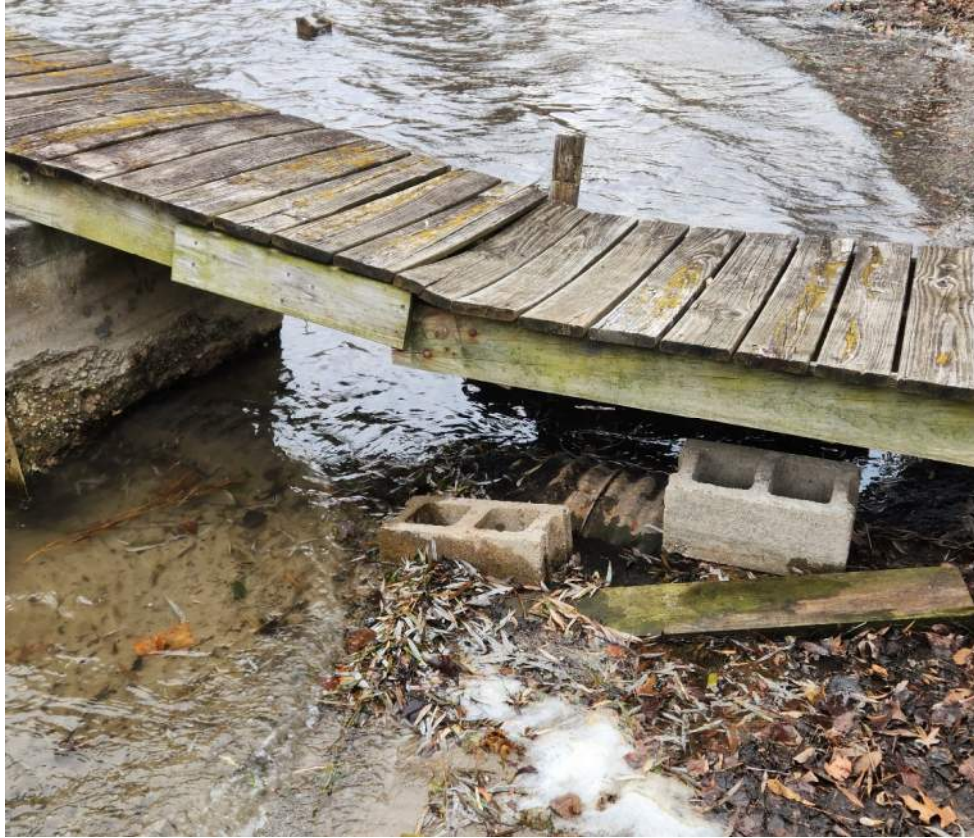
**Figure 9 – Intake Pipe under the Dock**

CMP pipe is in poor condition. Evidence of holes in the pipe. Pipe end seems to be surrounded with sediments which some of it made it downstream when the valve was opened, end treatment is recommended. The gate and valve for the outlet pipe are damaged and not operable. Staff has propped the gate closed to prevent water from flowing out. **NEEDS IMMEDIATE ATTENTION.**

Figure 9: Shows the intake pipe underneath the dock.

The intake pipe which is located immediately underneath the wooden dock has rusted out and is pitted in many locations along its length. The condition could be observed, during previous inspections, when the valve is operational as bubbles are seen where holes are present. Furthermore, the intake pipe lacks any screens as to prevent fish or debris from washing into the drain.

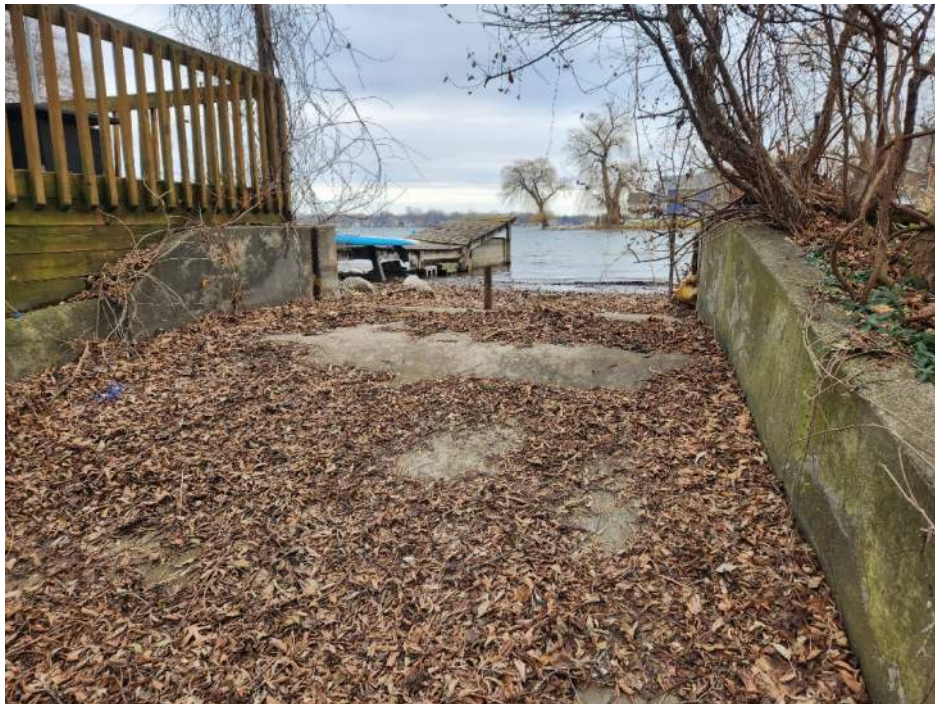
**Figure 10 – Spillway looking towards the Lake**

Figure 10: Shows the Spillway looking towards the Lake.

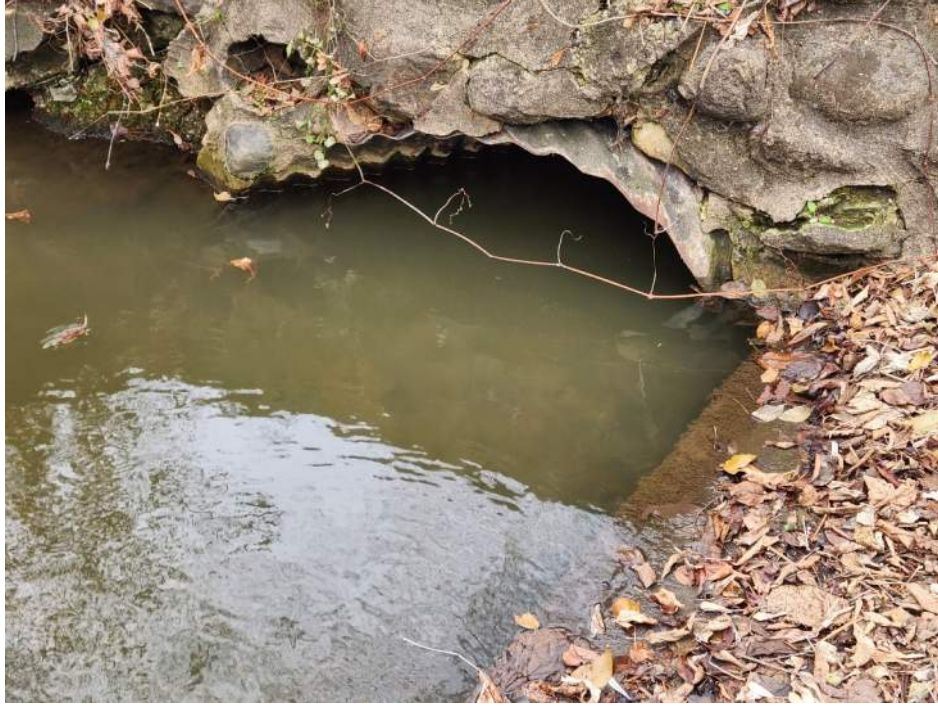
**Figure 11 – Bypass Pipe into Still Basin**

Figure 11: Shows the Bypass Pipe into Still Basin.

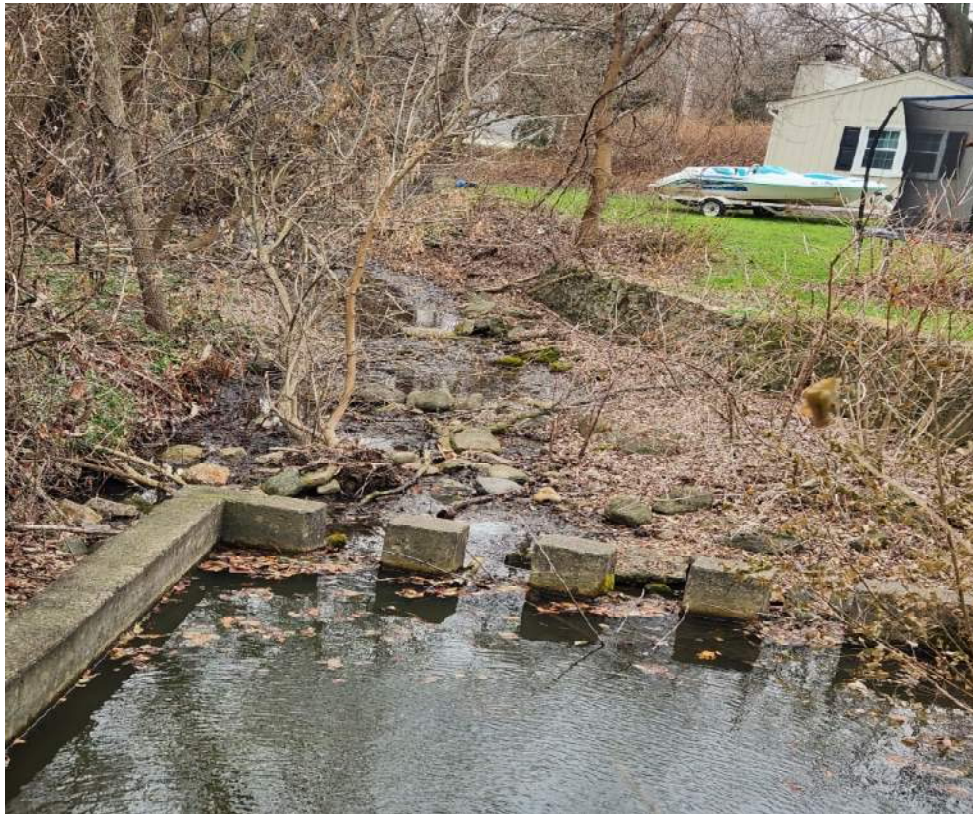
**Figure 12 – Open Channel Looking downstream**

Figure 12: Shows the open channel looking downstream toward the Marsh Rd. outlet structure.

The outlet drain is in good condition. Regular clearing and grubbing of vegetation are recommended within the open channel to remove obstructions.

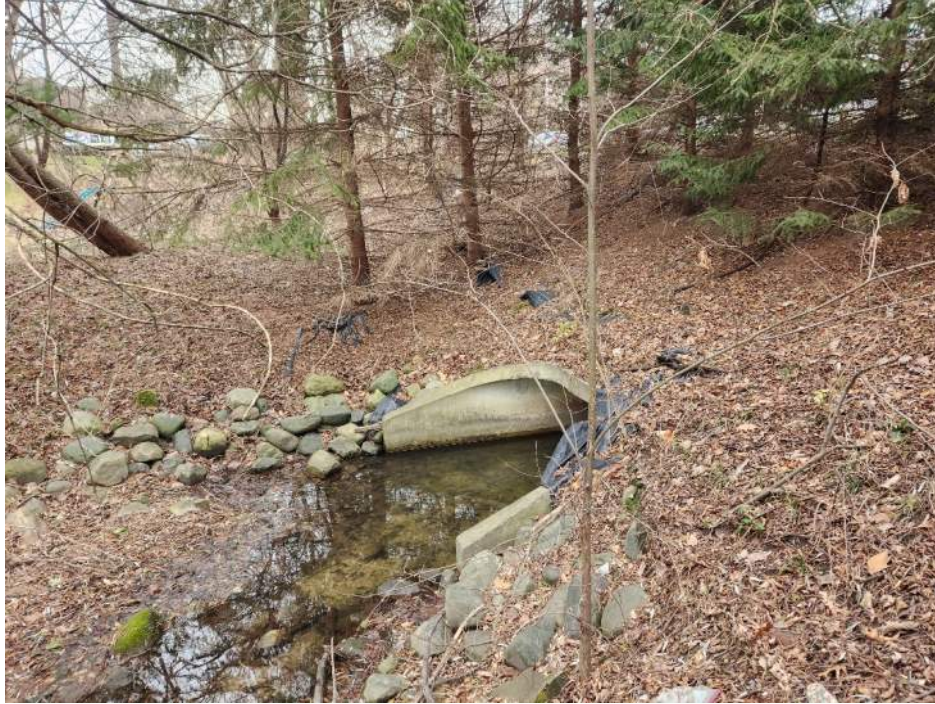
**Figure 13 - Marsh Rd. Outlet Structure: East End**

Figure 13: Shows the Marsh Rd. outlet structure on the east side of Marsh Rd.

The outlet culvert is in good condition. Regular clearing and grubbing of vegetation around the outlet culvert are recommended especially along the downstream end of the culvert west of Marsh Road.

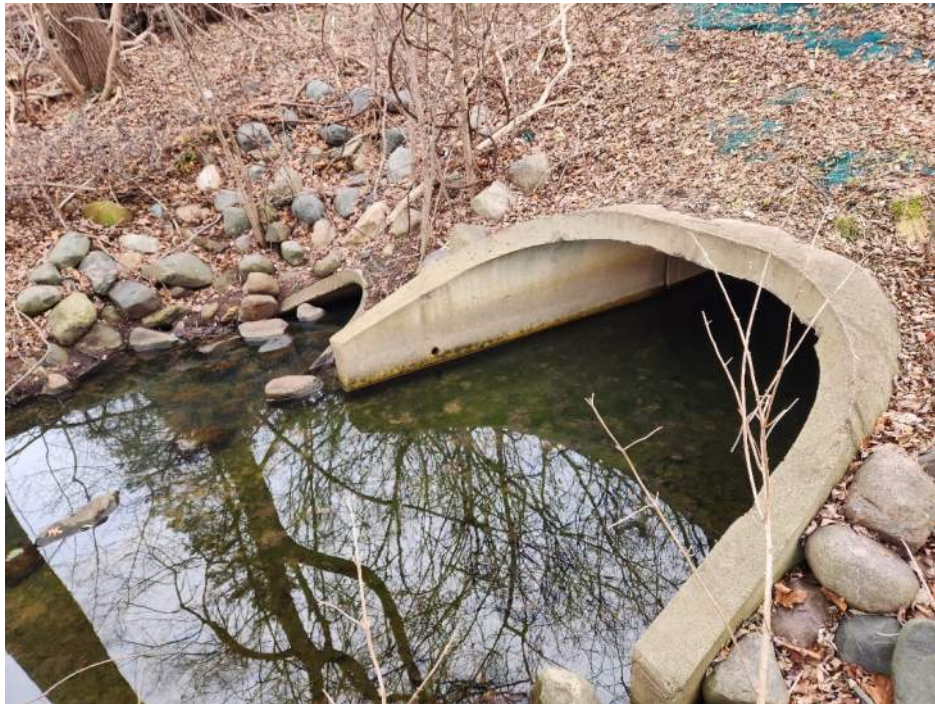
**Figure 14 – Marsh Rd. Outlet Structure: West End**

Figure 14: Shows the Marsh Rd. outlet structure on the west side of Marsh Rd.

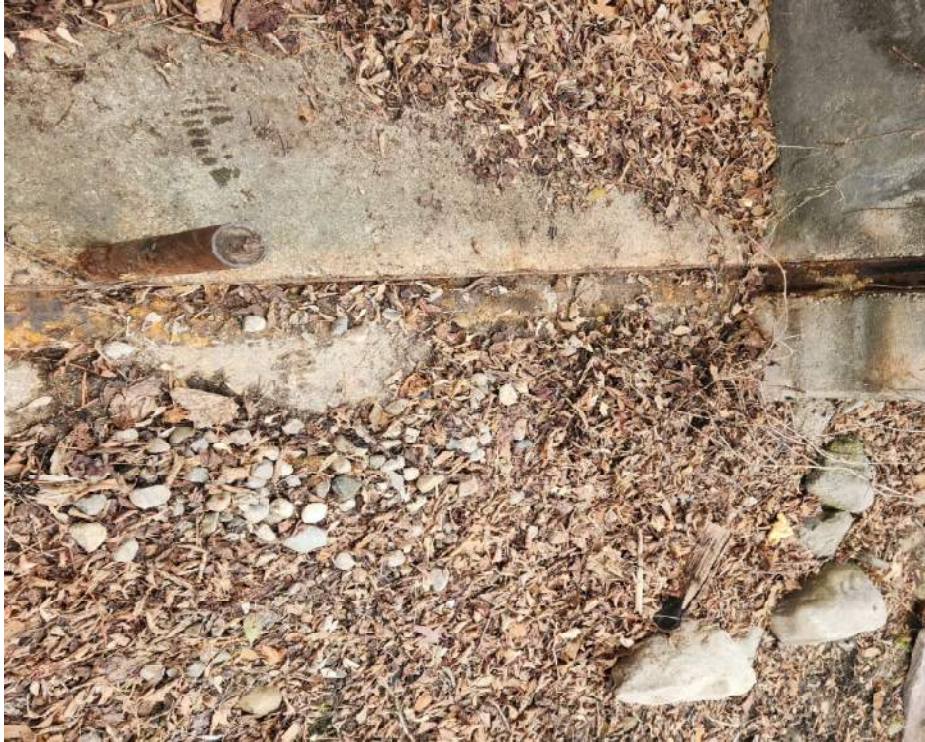
**Figure 15 – Stop Log Channel**

No stop logs were in place at the time of inspection. Water was low with no flowing water over the weir at the time of inspection. Stop log channel could use some upgrades but Maintenance personal report that the logs maintain the summer lake level satisfactorily.

Figure 15: Shows the Stop Log Channel.

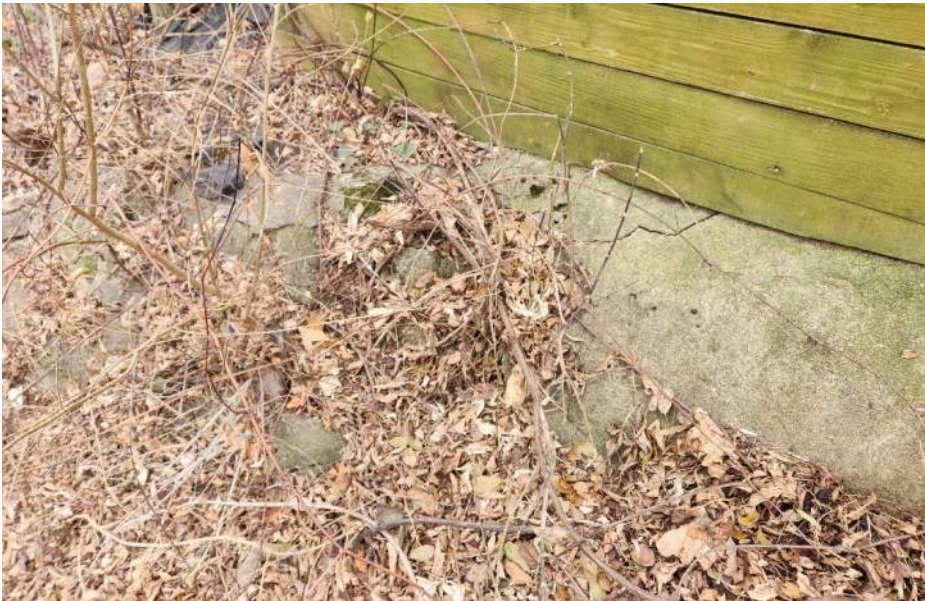
**Figure 16 – Spillway edge where vines are growing through cracks**

Figure 16: Shows the Spillway edge where vines are growing through cracks.

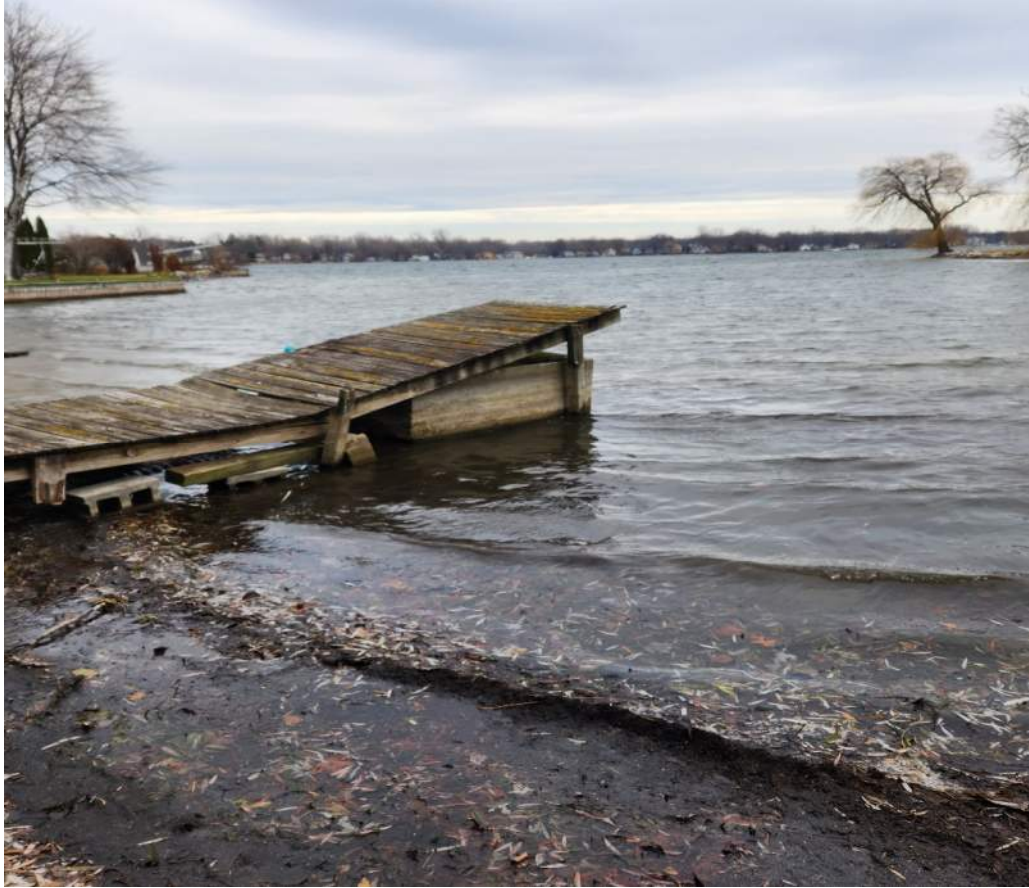
**Figure 17 – Dock Condition over the inlet structure**

There are no walkways or railings. Deck and dock over drawdown pipe and valve are in poor condition. The dock is falling apart and unsafe to walk on. The valve is inoperable, and the deck need some attention before the next inspection. **Recommend replacement of control structure, pipe, valve and related support structures ASAP.**

Figure 17: Indicates the Dock Condition over the inlet structure.

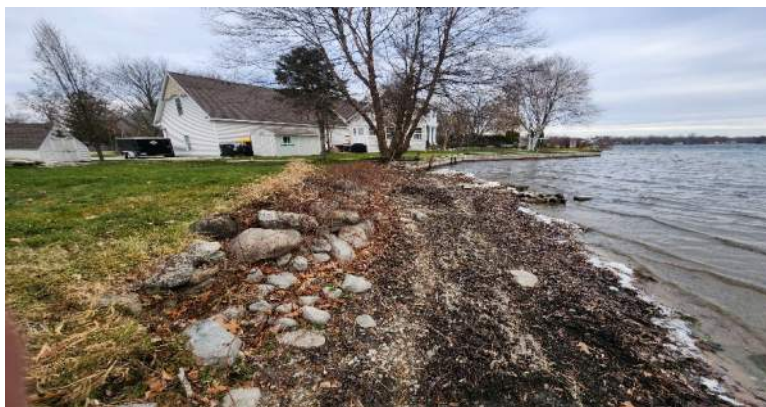
**Figure 18 – Seawall right of Spillway**

Figure 18: Shows the Seawall right of Spillway.
