CHARTER TOWNSHIP OF
MERIDIAN
TOWNSHIP BOARD
SPECIAL MEETING
September 29, 2015
6:00 P.M.

RE: **Daniels Drain Neighborhood Meeting**

NECESSITY OF DANIELS DRAIN IMPROVEMENTS
EXECUTIVE SUMMARY

To: Charles (Chuck) Barbieri, Foster Swift
From: Stu Kogge, PWS and Scott B. Dierks, PE, GEI Consultants
Date: July 30, 2015 (Update to June 30, 2015 Draft Version)
Re: The Ponds – Daniels Drain – Field & Hydrologic Modeling Assessments

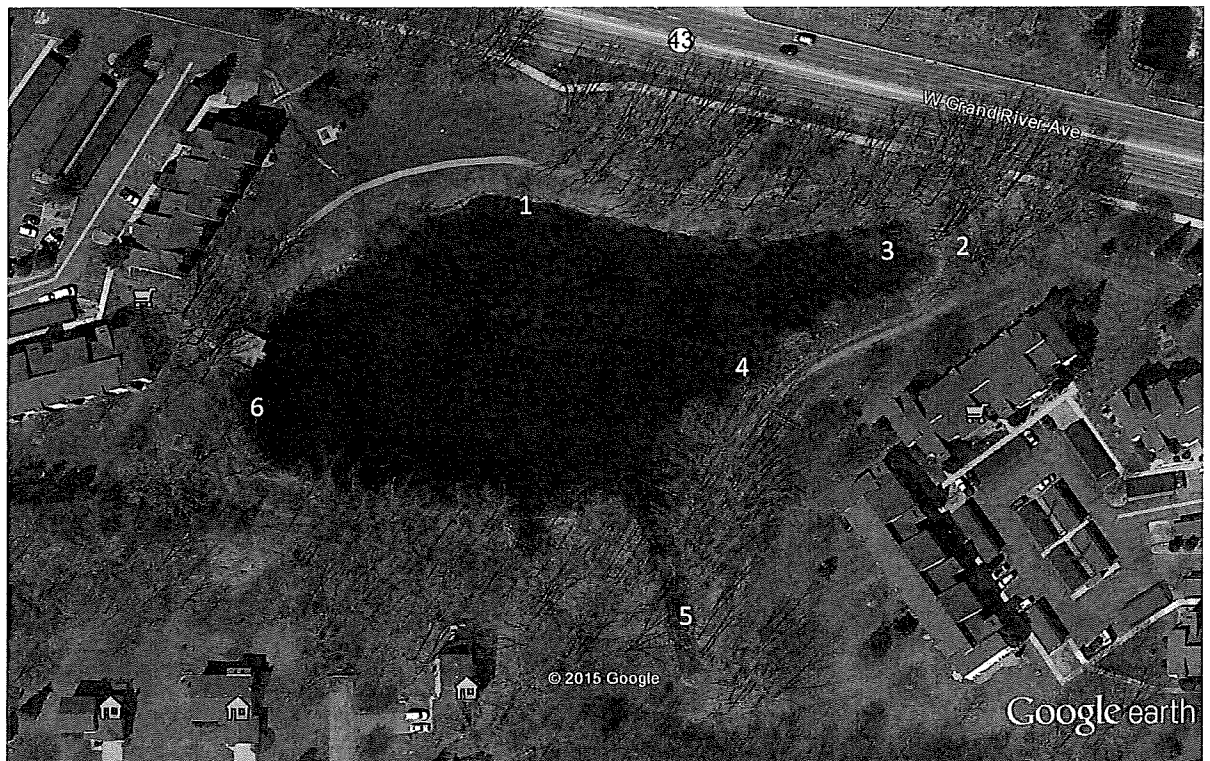
Figure 2 – Location of Sediment Samples

- Collected six (6) sediment samples (five (5) from around the pond and one (1) adjacent to the pond) as shown in Figure 2. These samples were analyzed for chlorides at Fibertec (lab in Holt, MI). The following are descriptions and discussions of their locations, soil characteristics and chloride levels:

- Sample #1 – within two (2) feet of the Grand River Avenue storm sewer discharge pipe located at the north end of the pond. Bottom soils are loam (mixture of sand and clay) with detrital and organic material on top.

- Lab analysis: 220,000 ug/l (220 mg/l)
 - Sample #2 – depressed land area (not within the pond) receiving overland runoff from Grand River Avenue right-of-way and lawn area of The Ponds (parallel to Grand River Avenue). A coarse sand and gravel mixture with minimal to no organic material.

- Lab analysis: non-detectable (less than 100,000 ug/l (<100 mg/l))
 - Sample #3 – northeast outlet end of the pond within 15 feet of riser pipe. Very silty clay texture with high amount of detrital and organic material.

- Lab analysis: 620,000 ug/l (620 mg/l)
 - Sample #4 – eastern end of the pond in the same location as Meridian Township’s water sample for chlorides was taken. Soils are mixture of sand, silt and clay with a moderate amount of detrital and organic material.

- Lab analysis: 450,000 ug/l (450 mg/l)
 - Sample #5 – southeastern end of the pond within 25 feet of a storm water discharge pipe to the pond. Soils are mostly coarse to fine grained sands with a minimal amount of detrital and organic material.

- Lab analysis: 130,000 ug/l (130 mg/l)
 - Sample #6 – western end of the pond within 15 feet of a storm water discharge pipe to the pond. Soils are mostly silty clay with minimal detrital and organic material otop of fibrous peat.

- Lab analysis: 550,000 ug/l (550 mg/l)

- The highest concentrations of chlorides were found at the storm water discharge pipe at the western end of the pond (550 mg/l) and the outlet at the eastern end of the pond (620 mg/l). The eastern end of the pond also had a high level of chlorides (450 mg/l) in the sediments. The high level of chlorides at these locations appears to be associated with high level inputs from the western storm sewer and accumulation of chlorides in the eastern end/outlet of the pond.

- Removal of sediment containing chlorides, and other pollutants not assessed to date, would improve upon the water quality of the pond and decrease chloride toxicity which is likely contributing to the apparent impact on the existing low numbers and diversity of macroinvertebrates within the pond.

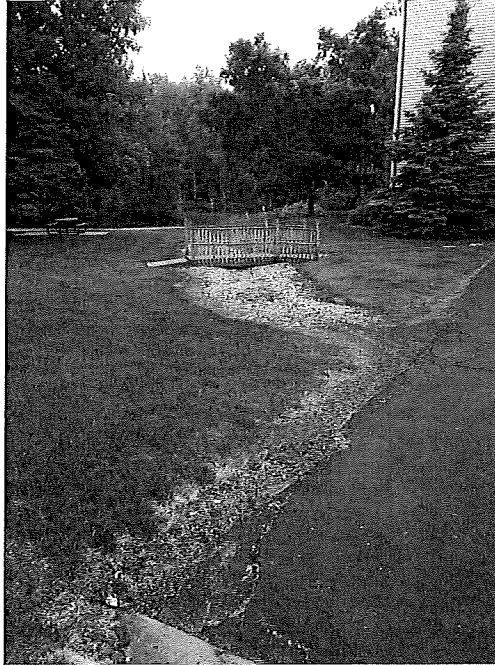
- Most drainage within The Ponds is via swale or sheet flow. The parking lots mostly drain to swale features that drain to the pond (Photographs 1, 7 & 8). Most of the swales end up draining over turf grass, with little evidence of erosion at the downstream end of these features.

Figure 1. Swale from north corner of west parking lot of The Ponds

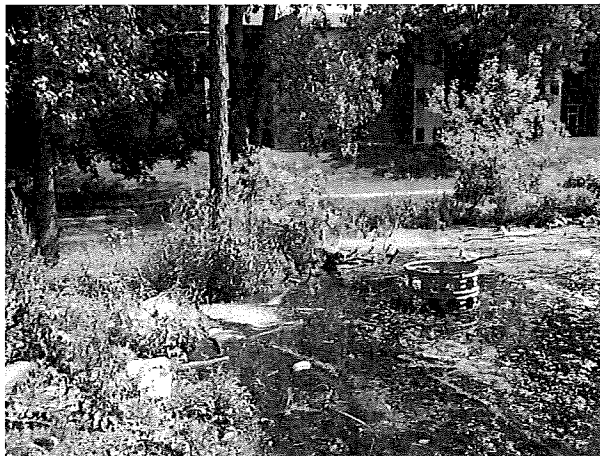
Figure 2. Walden Pond Outlet (note stain line at lower holes)

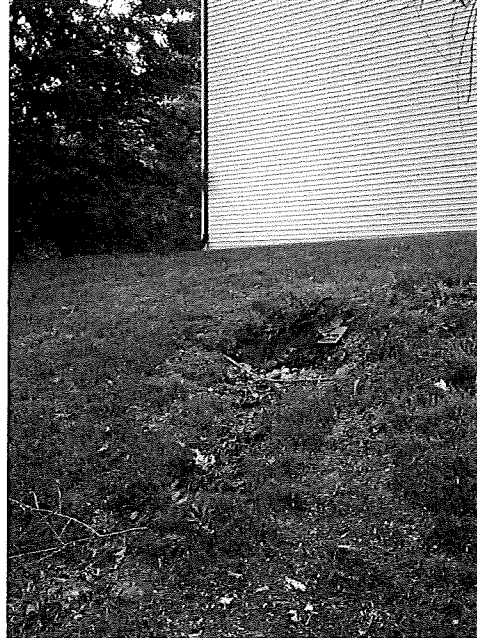
- All rooftop downspouts appear to release water on the ground, just off the building walls. Several downspouts actually release water at or near the top of the rise that the buildings sit on above the pond (Photograph 3). In some of these areas, these downspout outlets are causing hillside erosion, with some of that erosion making its way into the pond.

Figure 3. Erosion at roof drain outlet

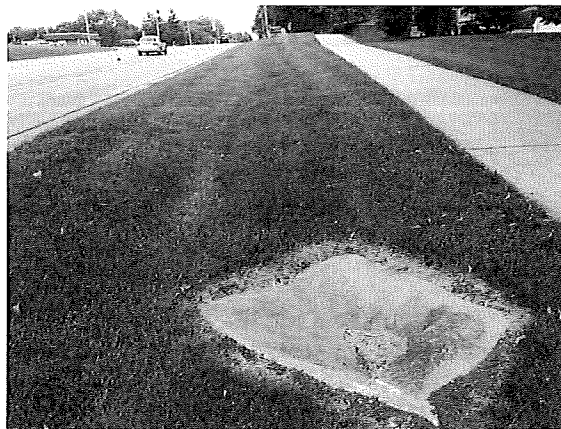
- Grand River Avenue runoff is contained via curb and gutter. There are several low points with inlets that collect roughly 1,500 linear feet of road runoff and direct it to the pond. There is also a roadside swale along the south side of the road that has two inlets (Photo 4) that appear to take swale drainage to the pond.

Figure 4. Grand Avenue southside swale inlet

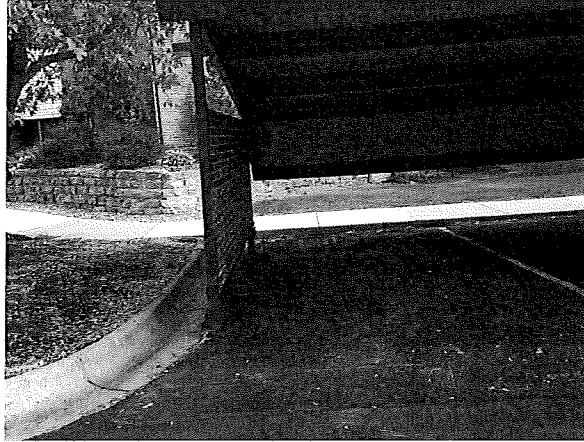
Figure 5. East side Parking Lot Inlet (to pond)

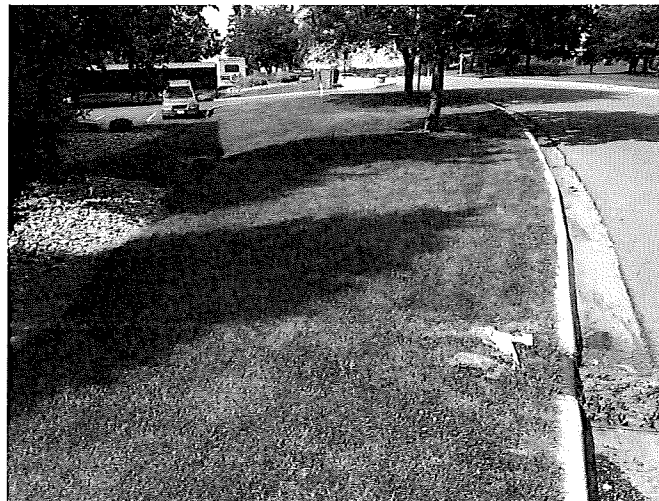
- By far and away the largest drainage area that may contribute the greatest runoff volume is from the developed areas south of the Ponds. The drainage from these areas dumps into the storm sewer (Photograph 6) that empties into the pond. As noted, the majority of the sediment, salt and fertilizers (among other products) may originate from these areas.

Figure 6. Street inlet on Paddock Drive

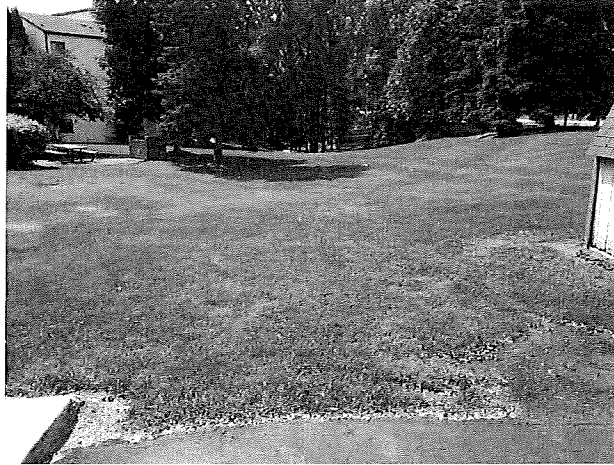
Figure 7. Grass swale off south corner of east side parking lot

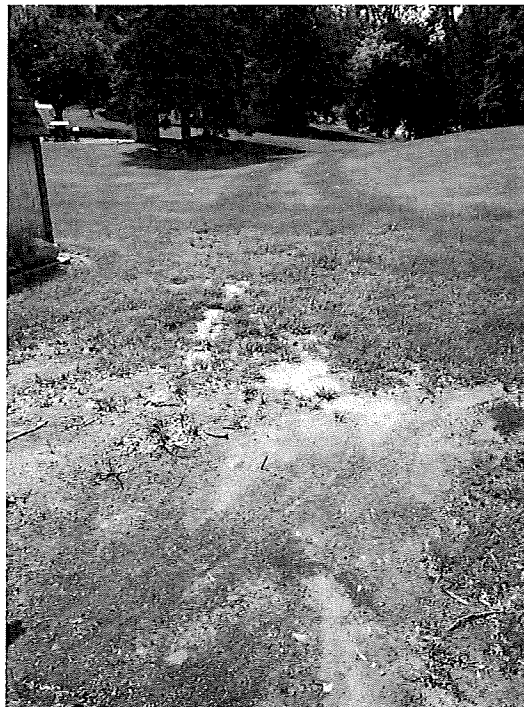
Figure 8. Grass swale off north corner of east side parking lot
