CHARTER TOWNSHIP OF
MERIDIAN
TOWNSHIP BOARD
SPECIAL MEETING
September 29, 2015
6:00 P.M.

RE: **Daniels Drain Neighborhood Meeting**

NECESSITY OF DANIELS DRAIN IMPROVEMENTS
EXECUTIVE SUMMARY

To: Charles (Chuck) Barbieri, Foster Swift
From: Stu Kogge, PWS and Scott B. Dierks, PE, GEI Consultants
Date: July 30, 2015 (Update to June 30, 2015 Draft Version)
Re: The Ponds – Daniels Drain – Field & Hydrologic Modeling Assessments

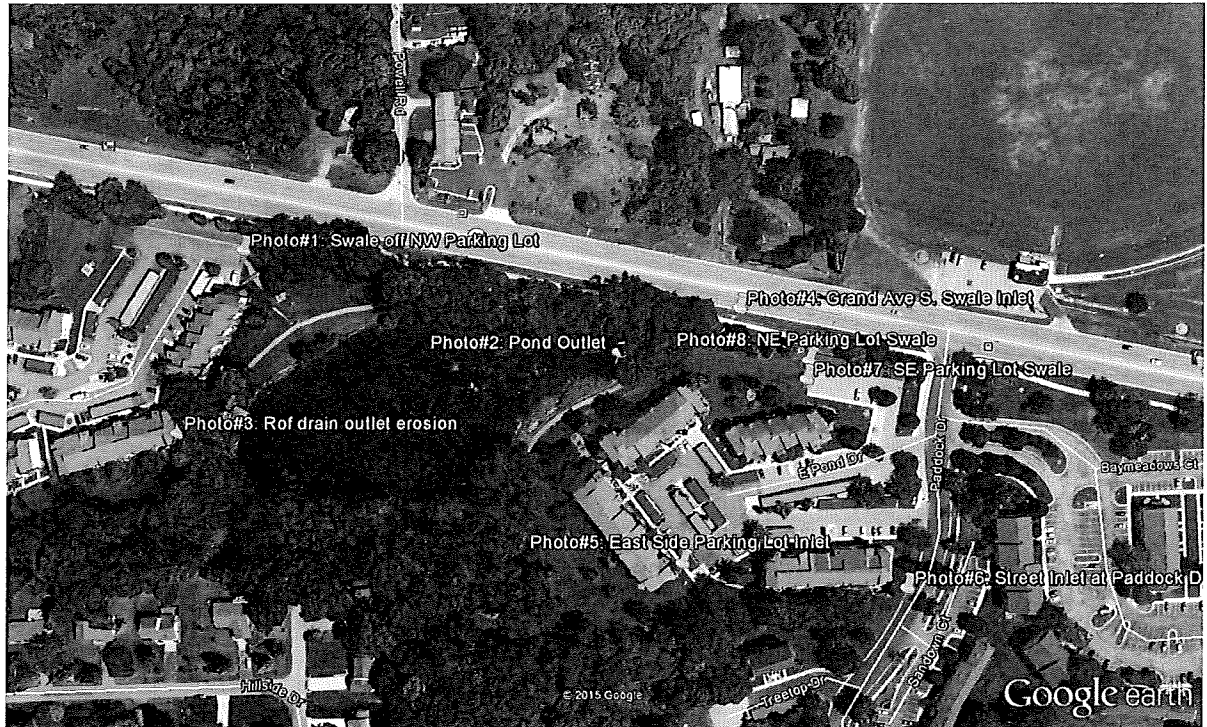
Figure 1- Location of Stormwater Features and Representative Photographs

- Most drainage within The Ponds is via swale or sheet flow. The parking lots mostly drain to swale features that drain to the pond (Photographs 1, 7 & 8). Most of the swales end up draining over turf grass, with little evidence of erosion at the downstream end of these features.

- All rooftop downspouts appear to release water on the ground, just off the building walls. Several downspouts actually release water at or near the top of the rise that the buildings sit on above the pond (Photograph 3). In some of these areas, these downspout outlets are causing hillside erosion, with some of that erosion making its way into the pond.

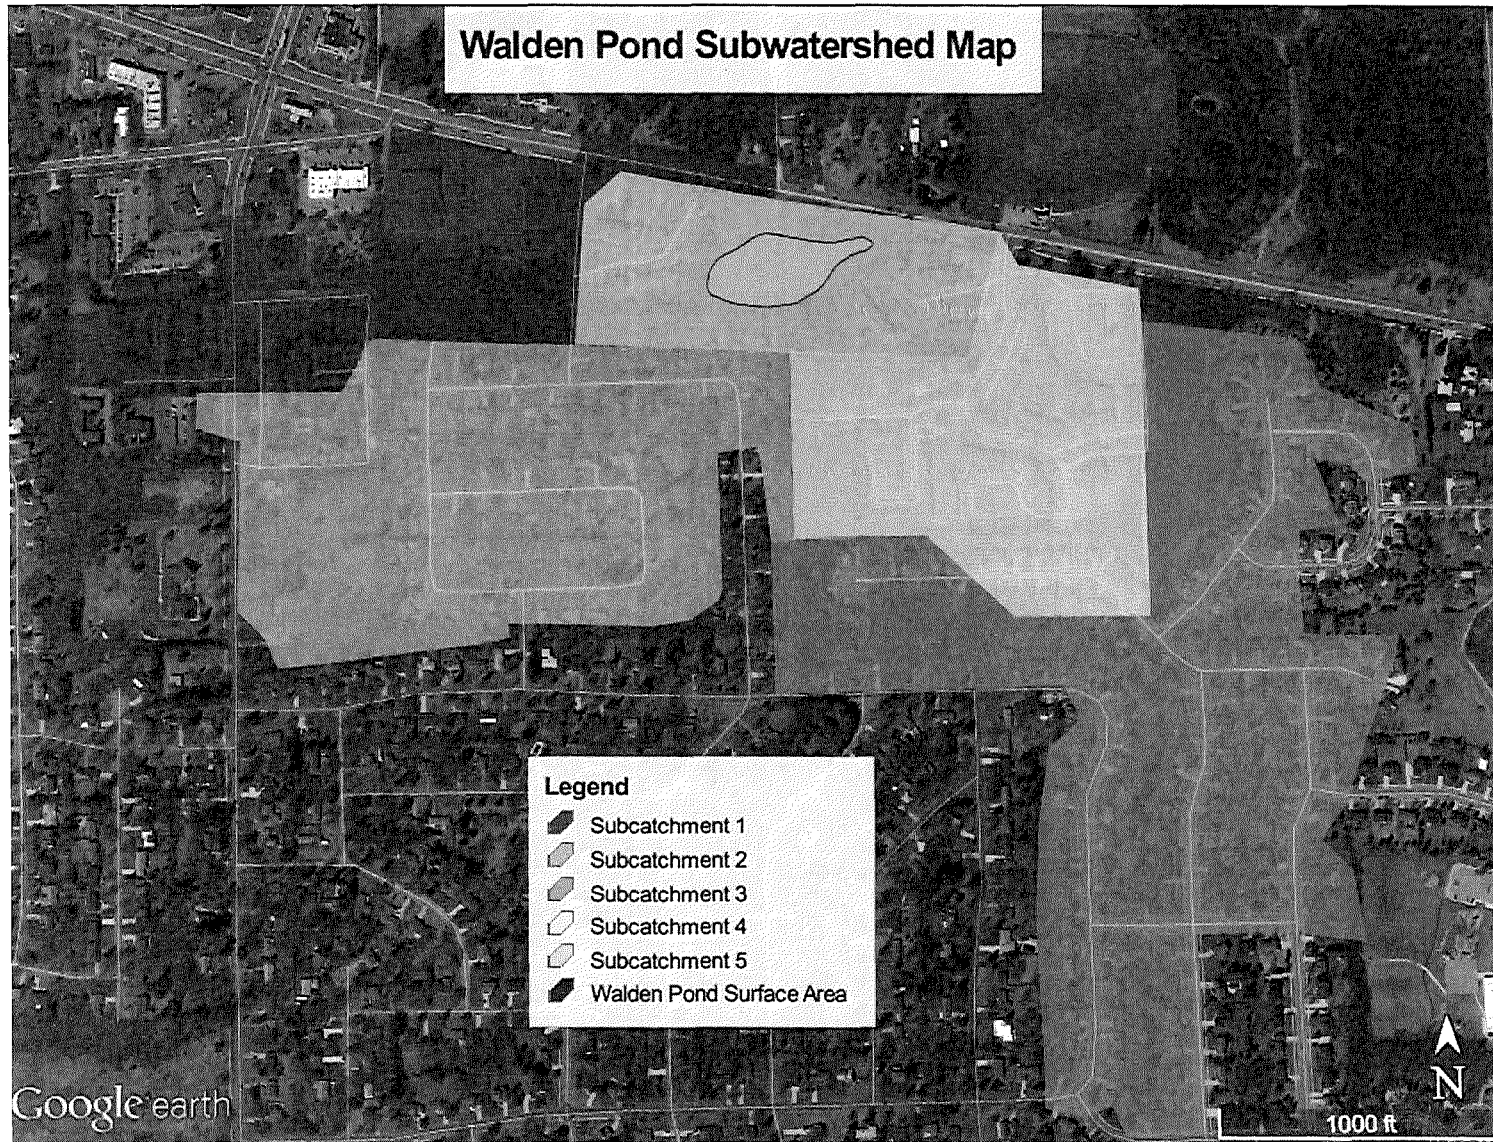
Figure 3. Walden Pond Subwatershed Map

We assumed loamy soils. The soil samples indicate a range of soils from silty clay to sand. Loam is roughly the average, particularly in its infiltration capacity, of the range of soil types found on site. We delineated subwatersheds based on 1) our presumption of The Ponds property boundary and 2) the major development areas outside of The Ponds. The subwatershed areas are shown in Figure 3 attached.
